# Klamath National Forest

## Best Management Practices

MONITORING REPORT

2012 Fiscal Year

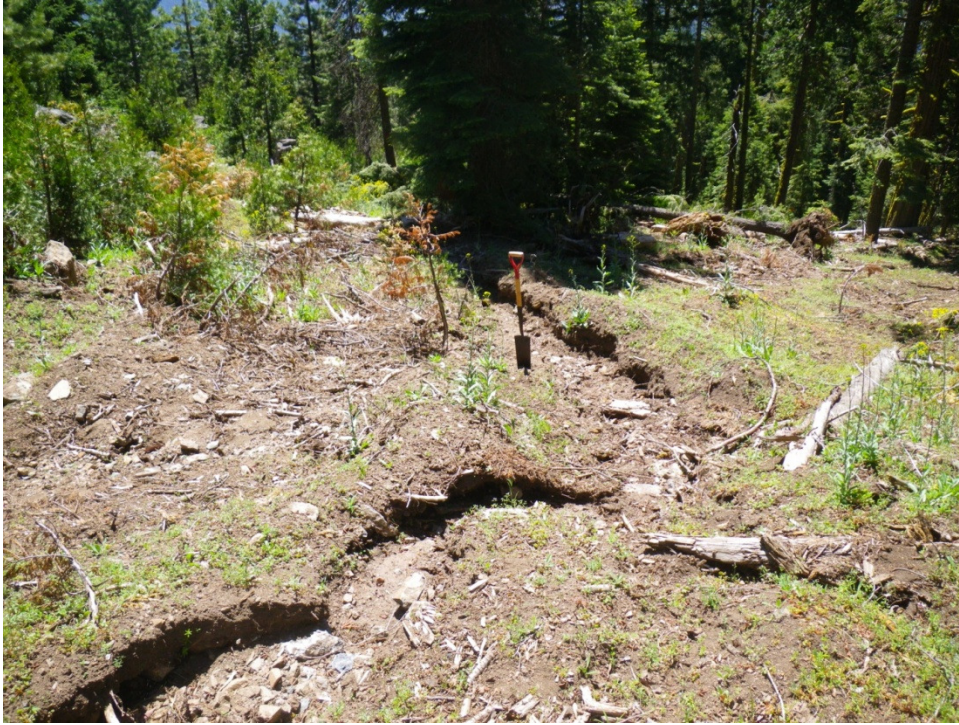
Tennessee Thin Unit 11A. Scott River Ranger District. Implemented/ Not Effective

At Tennessee Thin, Unit 11A, most of the skid trails had effective erosion control with properly functioning waterbars. However gully erosion and an ineffective waterbar was noted below FS road 45N59. Water had been diverted onto the skid trail, which had overwhelmed the waterbar, causing it to fail (Photo 1). It was discovered that water had been diverted upslope where a skid trail had crossed a swale. Material left in the swale as a result of skidding had blocked the natural flow path during an intense rain event causing water to divert out of the swale and onto the adjacent hillslope. The diverted water eventually returned to the natural channel about 100ft below road 45N59.

**Photo 1. Gully erosion and a failed waterbar on a skid trail in Tennessee Thin, Unit 11A**

The Timber Sale Administrator (TSA) and Scott River Ranger District timber staff were notified of the problem. On July 23<sup>rd</sup>, 2012 a compact utility loader was used to remove material from the swale to return the natural flow path back into the channel and repair failed water bars. Slash was used to cover exposed soil to reduce surface erosion. The swale did not have any evidence of scour and was not identified on the Sale Area Map as a Streamside Management Zone (SMZ), so it was difficult for the TSA to anticipate that erosion could have been an issue at this site. To prevent this from occurring in future projects, special attention should be paid to potential drainage issues where skid trails cross swales. If a skid trail disturbs the natural flow path in a swale, it should be corrected before erosion control features are accepted by the TSA.

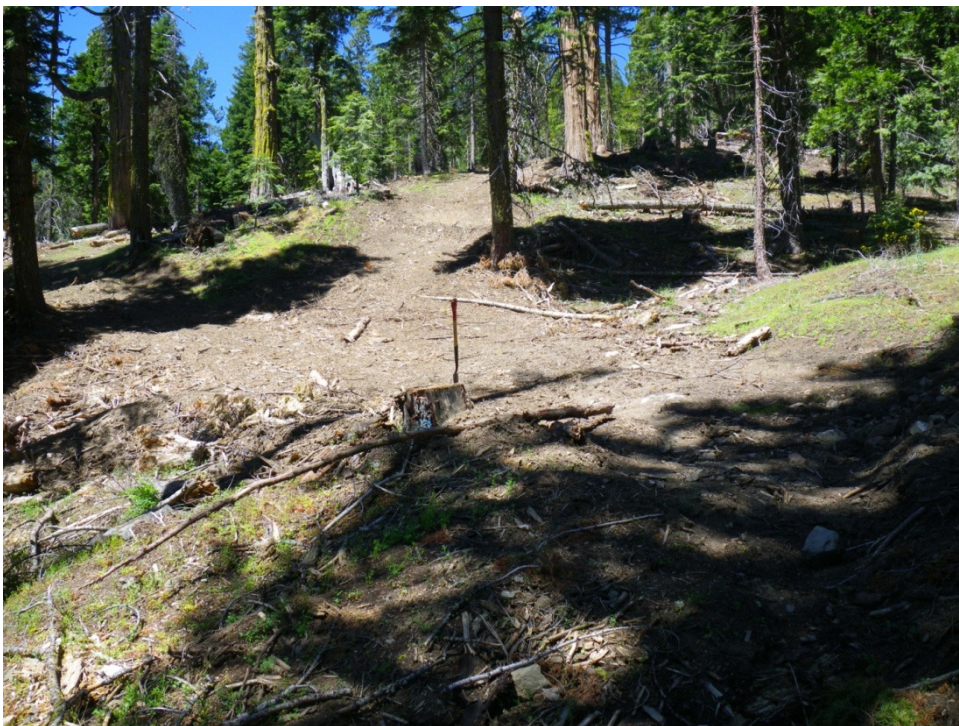
**Photo 2. Material left in a swale upstream of the failed waterbar had diverted water onto the hillslope**

Consideration of subtle drainage features like swales need to be emphasized when applying or approving waterbars or other erosion control features on skid trails. In the case of the Tennessee Thin Unit, a skid trail crossed a swale that under normal conditions did not carry flow and was not identified on the sale area map as a Streamside Management Zone. An intense rain event combined with impacts of skid trails and thinning resulted in increased overland flow that was subsequently diverted out of the swale. Timber Sale Administrators were involved in the monitoring and corrective action for the Tennessee Thin Unit and will apply lessons learned from this evaluation to future timber sales.

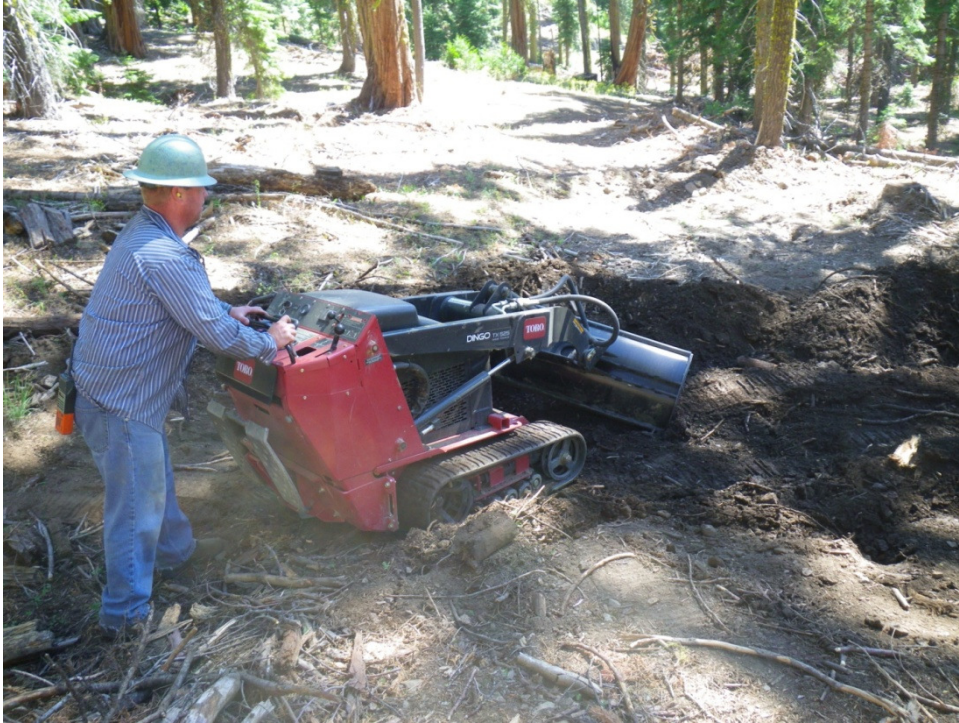
**Photo 3. Scott/Salmon River Ranger District staff removing material from the swale to redirect flow back into the channel**

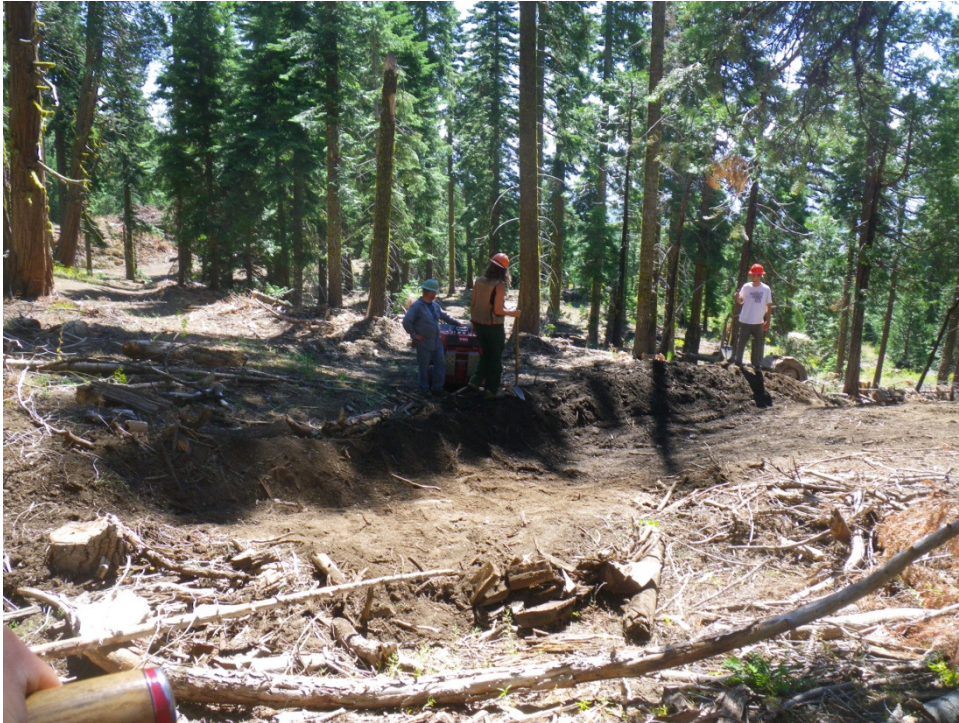
**Photo 4. The result of clearing material from the swale to divert water back into the channel. Slash was then placed over disturbed soil.**

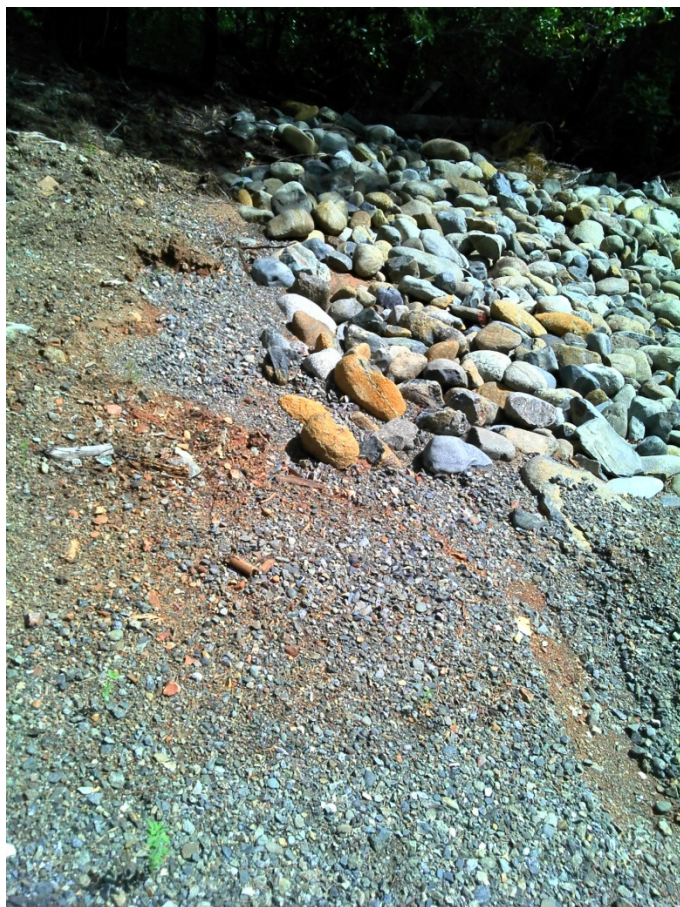
Mill-Luther Phase 3-18N31. Minor Departure/ At Risk. Happy Camp Ranger District. Minor problems with BMP implementation and effectiveness were noticed at three rolling dips. At one rolling dip, rip rap was not placed correctly and water drained around the rip rap instead of draining through it (Photo 5). At other locations, the gravel placed in the rolling dip did not prevent rilling (Photo 6). The project plans called for ¾ in. minus gravel to be placed over rolling dips. This size aggregate did not stand up to the flow over some of these rolling dips. Compounding the issue at this site is that concentrated water from spur roads upslope of 18N31 has increased flow over the rolling dips. These spurs are used to access a power line and are maintained by the power company under a special use agreement.

**Photo 5. Rip Rap was not placed correctly to filter runoff from rolling dip**

Watershed staff and engineering will review the site in 2013 to determine if larger aggregate should be brought it to better armor the dips. Additionally, the group will evaluate the spur roads that access the power line to determine if waterbars are needed to dissipate surface flow before reaching rolling dips.

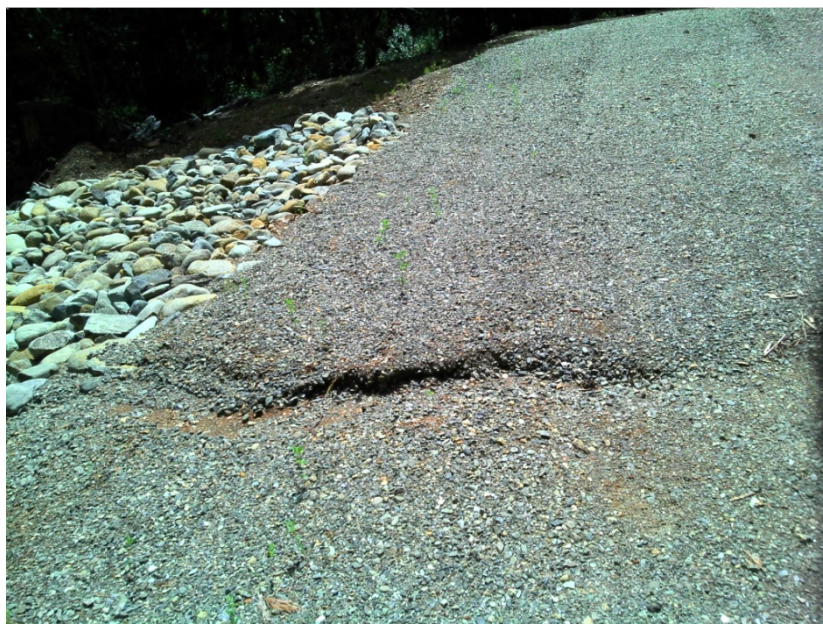
**Photo 6. Rill erosion of gravel placed on a rolling dip**

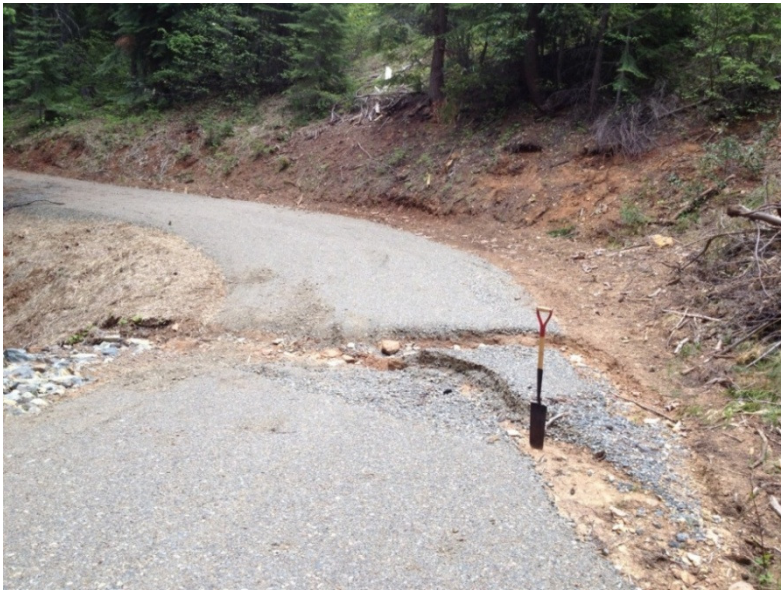
Last Canyon- 44N45A. Scott River Ranger District. Not Implemented/ Not Effective. Work on this project had been partially completed in the fall of 2011. A storm in the winter of 2012 resulted in gullying at this site, before all of the aggregate had been brought in and compacted (Photo 7). The gullying was brought to the attention of the project engineer and corrective action was taken by placing more aggregate on the rolling dip and compacting the road surface (Photo 8). With these corrective actions and the re-establishment of vegetation on the cut slopes, this site is expected to pass BMP effectiveness when watershed staff re-visits the site in 2013.

**Photo 7. Gully erosion on a rolling dip**

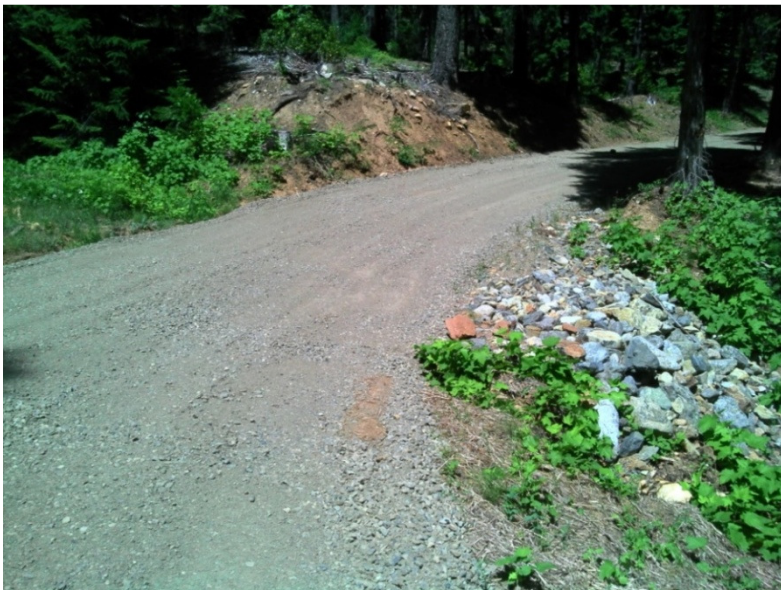
**Photo 8. Corrective action taken to fix the gullying on the rolling dip**

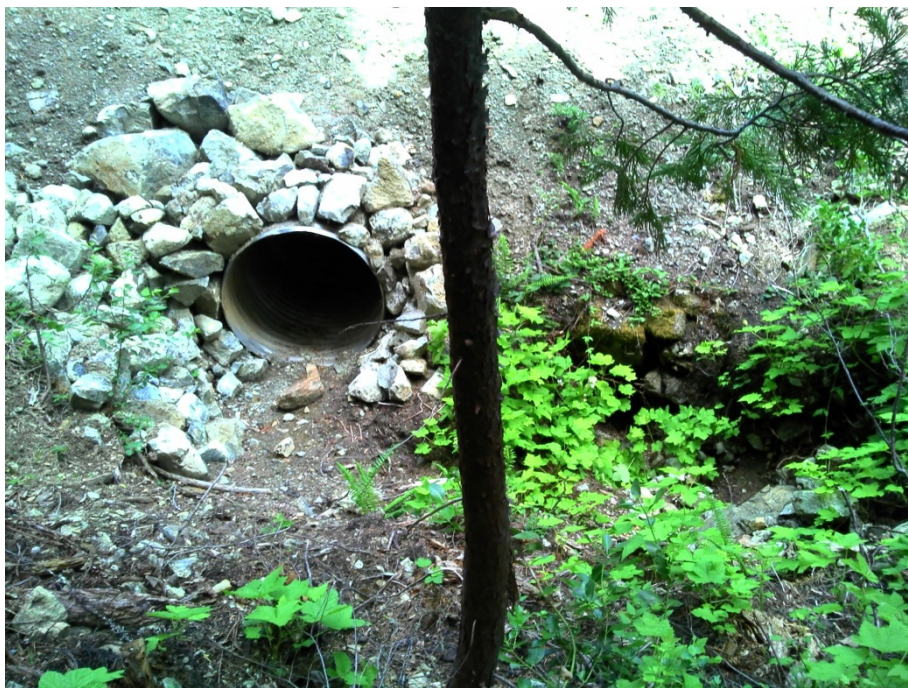
Mill-Luther Phase 3- 18N32 M.P. 0.52. Happy Camp Ranger District. Not Implemented/ At risk. Project plans called for removing an existing culvert, reducing the fill in the crossing, and installing a new culvert. The project plans had been carried out to specifications, with the exception of removing the old culvert (Photo 9). At the time when work was being done, water was still flowing through the old culvert, so it was left in place and the new culvert was installed adjacent to it. A large volume of material still remains in the fill, but the risk of crossing failure was reduced by increasing the capacity with a new larger culvert and by installing a critical dip over the fill. At the time of the evaluation, water was heard running under the old culvert, which could undermine the fill. Watershed specialists and engineering staff will re-visit this site in 2013 to evaluate the risk failure at this crossing and determine if additional work needs to be done.

**Photo 9. In-channel construction Photo after new culvert was installed. The new culvert is on the left and an old culvert is slightly below grade on the right.**

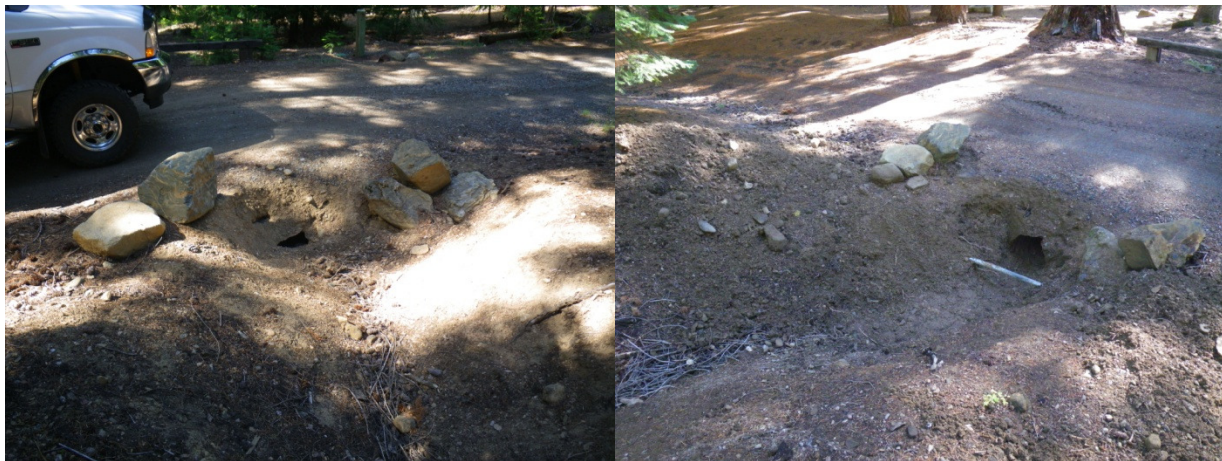
Trail Creek Campground. Salmon River Ranger District. Implemented/ Effective. Monitoring at this sight found some drainage structures including a culvert and ditch that need to be cleaned out. District recreation staff returned with a small excavator soon after to perform the recommended maintenance.

**Photo 10 a and b. Culvert at the Trail Creek Campground before (left) and after (right) cleaning.**

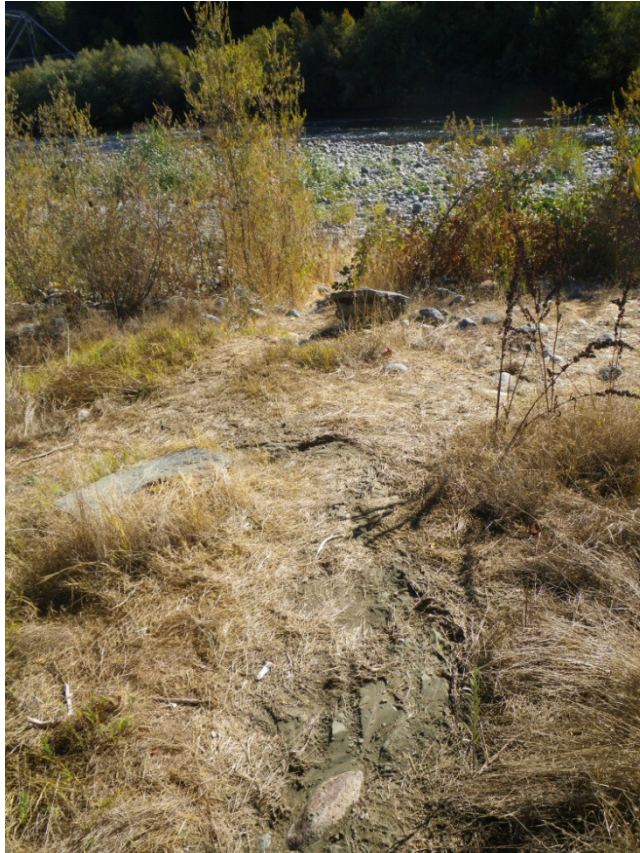
Indian Creek River Access. Happy Camp ranger District. Implemented/ At Risk. Monitoring found runoff from the parking lot for Indian Creek River Access deposited on a small flat between the parking lot and the creek. Due to the close proximity of the parking lot to the creek, the erosion from the parking lot should be closely monitored and to determine if improvements should be made such as adding new gravel or installing a sediment filter or barrier to prevent sediment from reaching the creek during an intense rain event. The issue was discussed with the District Recreation Officer and options to install additional gravel at the parking area being considered.

**Photo 11. Sediment from the Indian Creek River Access parking lot deposited on a flat with the SMZ**

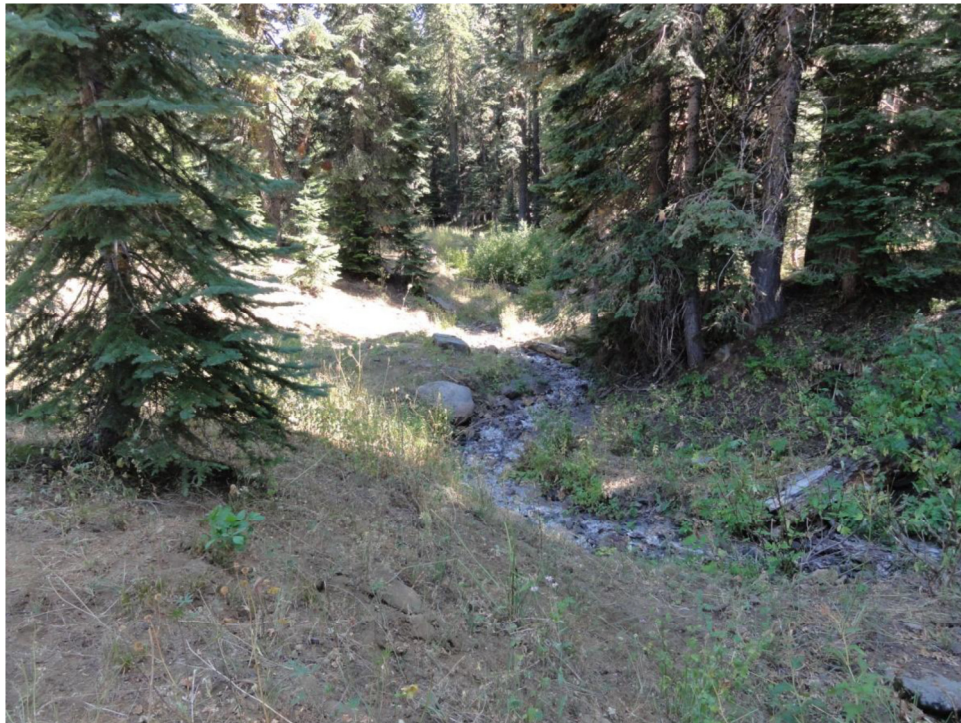
The site evaluated drains Turk Lake and is a downcut rocky channel interspersed with riparian shrubs. The downcutting was probably caused by historic grazing practices in conjunction with natural flooding and high spring flows. The creek appears to be stabilizing as evidenced by the growth of riparian shrubs and herbaceous vegetation in the bottom of the channel. The stream is shaded both by streamside shrubs and trees. The walls of the banks are not well vegetated and have very loose soil; therefore leaving the site vulnerable to erosion. Other factors contributing to streambank instability and erosion include one major cattle crossing and gopher activity. Implementation standards and guidelines for herbaceous utilization, woody utilization and stream bank alteration were met fully; grazing was light to moderate. Effectiveness criteria were in the highest category other than the streambank stability (less than 70% stable) and floodplain erosion categories. No changes in grazing management are recommended for this unit at this time, but the Multiple Indicator Monitoring Plot established here should be reread by the year 2015 to establish trend for this site and determine if further actions are warranted. The impacts of historic grazing practices in this allotment have contributed to minor impacts on beneficial uses due to increased sedimentation. The allotment seems to be on an improving trend towards greater streambank stability but follow-up monitoring will be required to confirm this trend.

**Photo 12. Big Ridge Allotment, Turk Lake Unit. Stream channel shows <70% bank stability.**

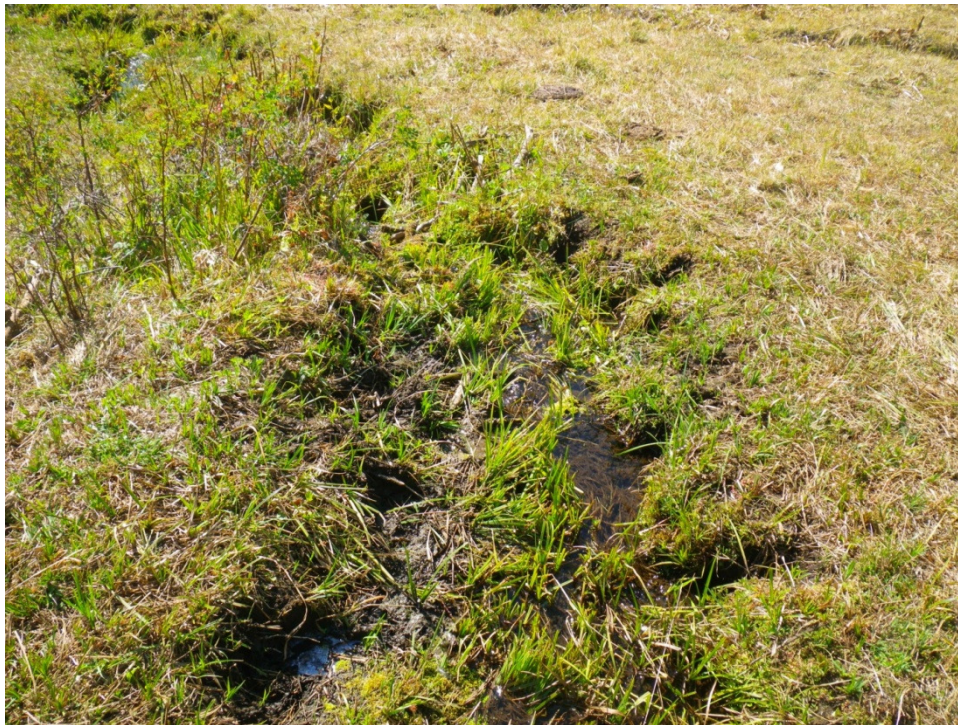
The site that was evaluated is within a sloped moist meadow which is centrally drained by a small creek. The reach is lined with a diverse community of sedges, grasses, and forbs. Very few woody species are present within the meadow. The streambanks were mostly covered by deep rooted vegetation with little evidence of erosion. Some localized trampling was observed which may put the creek at risk for widening. Implementation standards and guidelines were met for herbaceous utilization but woody alteration was within 80% of the standard. Effectiveness criteria were in the highest category other than streambank stability which was less than 70% stable. Due to the fact woody utilization did not meet standards; the permittee was called to remove cattle from the unit and the AOI for 2013 will be changed. It was also recommended that a Multiple Indicator Monitoring Plot be established in the evaluated reach to determine condition and trend of the creek. No trend could be deduced for streambank stability because prior data wasn't available however; the area did not receive cattle use during the 2010-2011 seasons which may suggest factors other than livestock management are contributing to the bank instability. Streambank instability from trampling resulted in very little effects to beneficial uses, but the creek is at risk for widening in the future if corrective actions were not taken. Follow-up monitoring will be necessary to see if corrective actions have resulted in an improved trend in streambank stability.

**Photo 13. Grouse Creek Allotment, Masterson Meadow Unit. Stream channel shows <70% bank stability.**

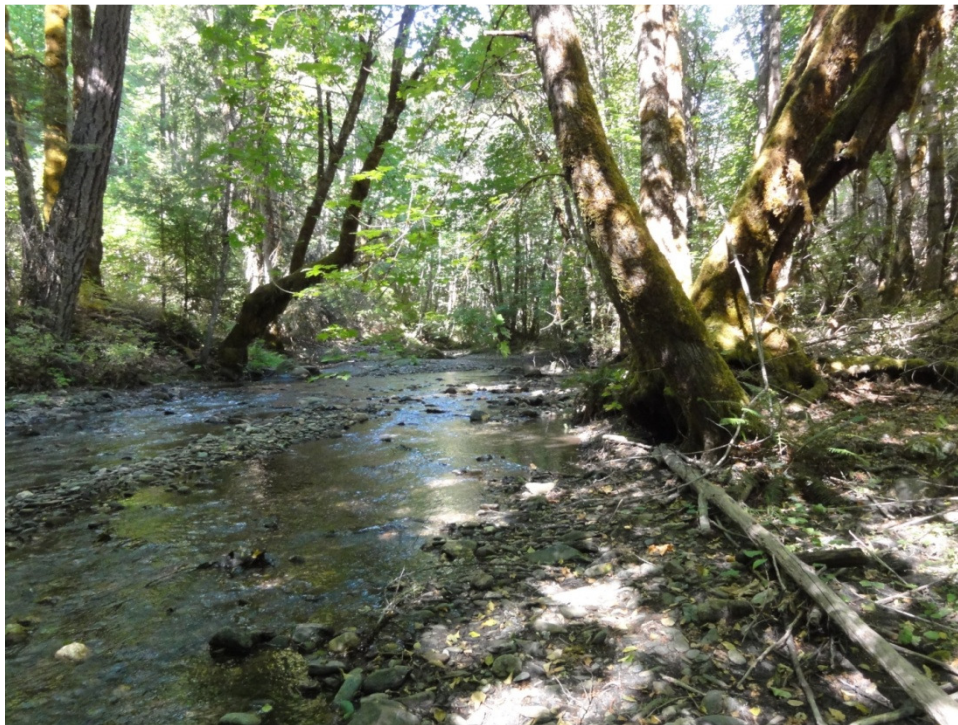
The site evaluated is a shallow, wide portion of Horse Creek that is located in the spring range unit. This site is not near a typical meadow key area like the other evaluated sites, but is important to monitor because it is near transitory range and is one of the few cattle-accessible anadromous areas of the creek. The plant community type consists of Douglas Fir, Bigleaf Maple, Western Raspberry, and California Hazel which provides complete shade for the creek. The creek is fairly close to a main road, however, streambank stability is high (82%) due to the rocky streambed and the deep rooted plant community. There were no observances of cattle caused alteration to the streambanks. Implementation standards and guidelines were met and all effectiveness criteria were in the highest category.

**Photo 14. Horse Creek Allotment, Lower Horse Creek Unit. No observable grazing impacts on streambank.**

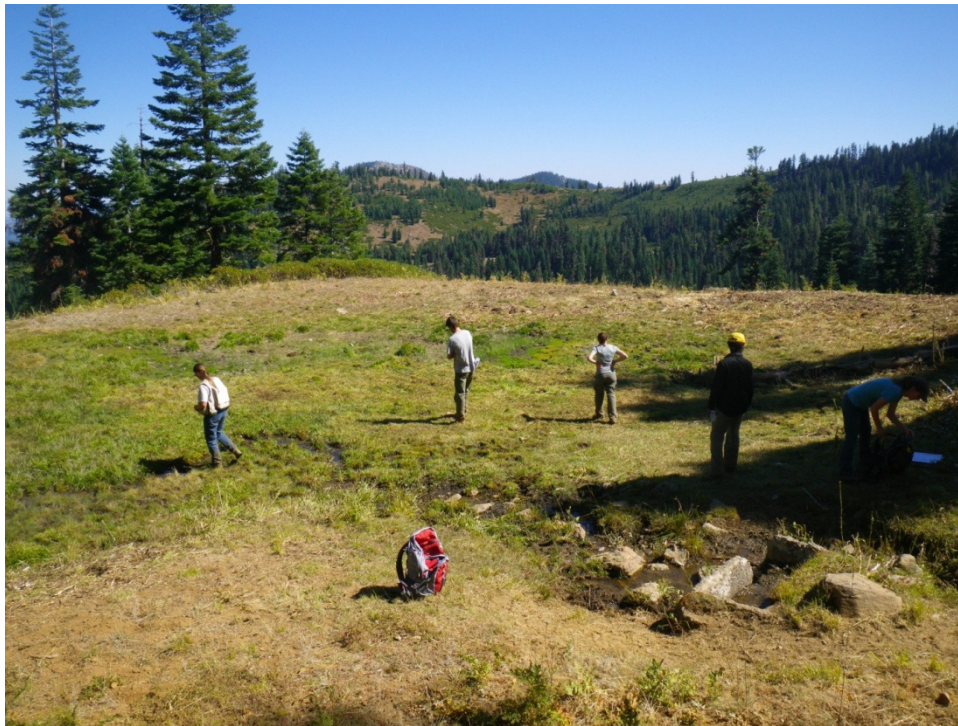
The area evaluated was a spring site which was developed prior to 1940. It is frequented often by cattle due to the fact that it is the only water source on the ridge of a large meadow complex. The site evaluated is small (less than ½ acre) and contains a small pond surrounded by a wet meadow dominated by sedges. No woody shrubs were present at the site. Lentic Habitat was the only effectiveness section

evaluated for cattle impacts because Kuntz Creek is steep and armored by a large patch of alder. Monitoring results indicated that hoof prints affect more than 10% of the spring area and may be impacting soil saturation, however the herbaceous vegetation appeared to be maintaining vigor and was mostly composed of mid to late seral species. Implementation standards and guidelines were met. This allotment will be undergoing NEPA analysis next year and it was recommended that options for fencing the spring and placing a trough outside the meadow be examined. The impacts to the trampling in the spring area did not impact downstream beneficial uses of water. Sediment and temperature on Kuntz Creek were not impacted because the spring and pond are not connected to the creek. Kuntz Creek is protected from disturbance because it is well armored by alders and fairly steep, making it inaccessible to livestock.

**Photo 15. Lake Mountain Allotment, Kuntz Creek Unit. Hoof prints have impacted >10% of the wet meadow.**

G24	Lake Mtn	Pass	Not Effective	No changes in grazing management. Area to be evaluated under NEPA in 2013. Recommend Fencing or placing a trough outside the meadow.	Monitor condition of meadow for BMP and NEPA analysis
G24	Grouse Creek	Minor Departure	At Risk	The permittee was called to remove cattle from the unit and the AOI for 2013 will be changed	Monitor woody alteration and streambank stability to see if management changes for 2013 are adequate

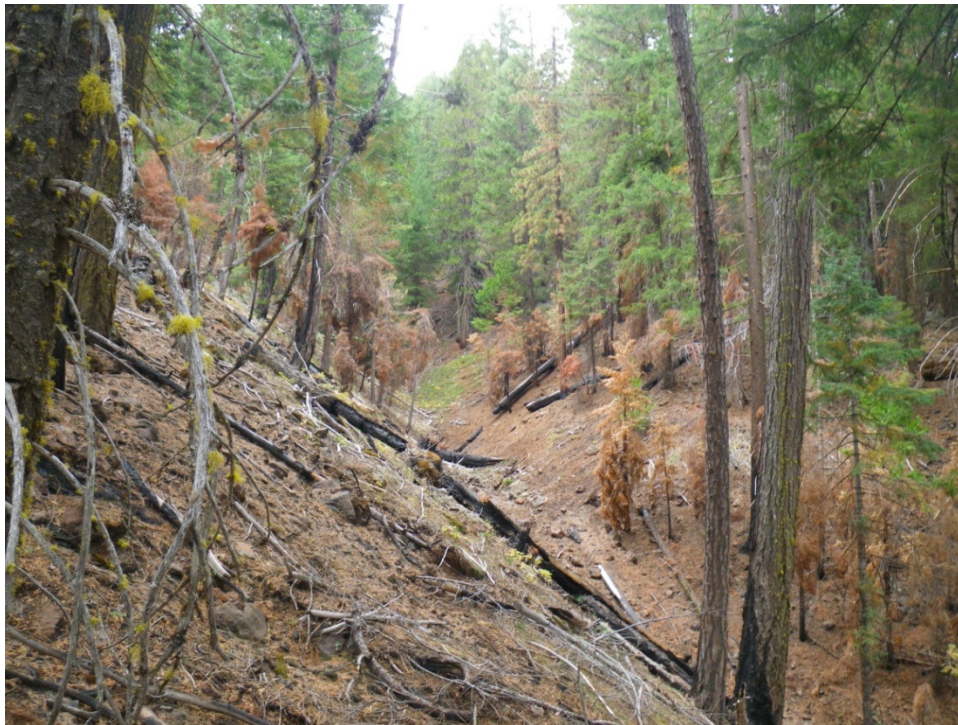
The NEPA document that covers the LSR Jackpot Burn specifically restricted under-burning in inner-gorges and unstable areas in Unit 6 due to erosion concerns. These restrictions were not carried forward in the Burn Plan for this project; nowhere in the burn plan were inner-gorges or unstable areas mentioned. Upon a field review of this unit, most of the inner-gorges were either burned very lightly or not at all due to the fact that fuels in these areas were very sparse. Ground cover in these inner gorges is sufficient to prevent sheet or rill erosion into intermittent drainages.

**Photo 16. Jackpot LSR Unit 6 with very light under-burn in inner-gorge**

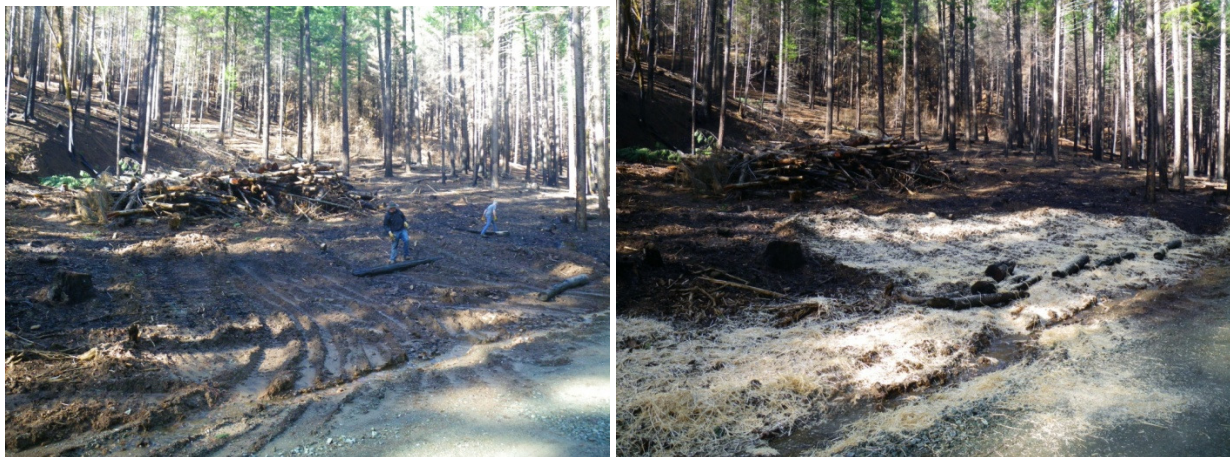
On December 4<sup>th</sup> 2012, watershed specialists and a timber sale administrator reviewed landings used for the Thom Seider Project. Two landings along FS road 48N20 were evaluated for rilling or concentrated flow on the landing surface and sediment delivery to Seaid Creek. Rilling and concentrated flow was evident on the landing and sediment was delivered to the inboard ditch adjacent to the landing. A new culvert that was installed to drain the inboard ditch prevented sediment from being delivered to Seaid Creek. The reason for erosion problems on the landing surface was two-fold; soil cover on the landings had been consumed in the 2012 Goff Fire leaving the landing vulnerable to erosion, and equipment used in the Goff BAER storm-proofing project had driven on the landing as a turn-around which concentrated flow down tire ruts and into the inboard ditch. Corrective action was taken by using logs to block vehicle traffic onto the landing and cover the landing with weed-free straw to prevent further surface erosion.

**Picture 17 a and b. Thom Seider landing before corrective action on the left and after corrective action on the right**

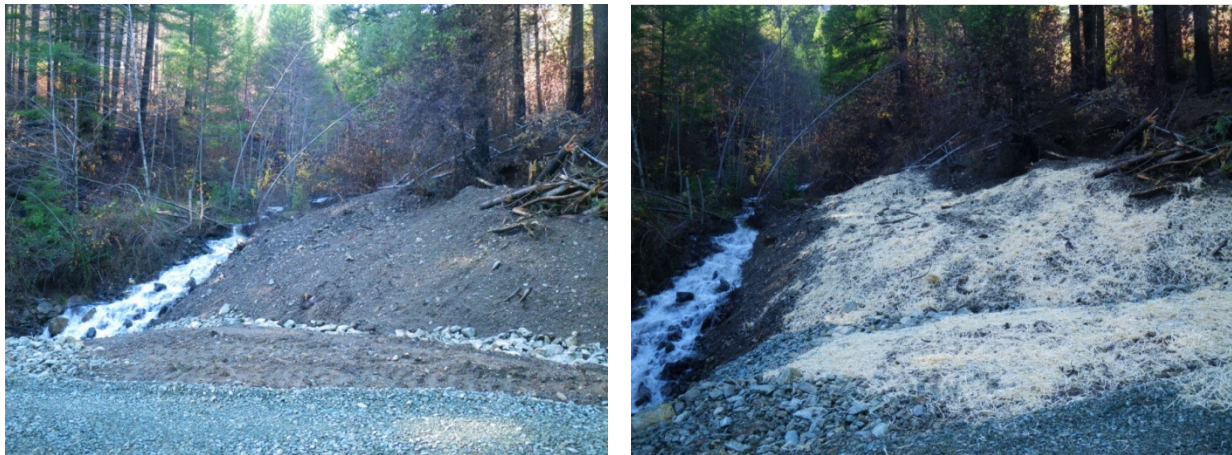
On December 5<sup>th</sup> 2012 watershed specialists reviewed in-channel construction BMPs on the Goff Fire Burned Area Emergency Response (BAER) Project. The project was designed to storm proof FS road 48N20 before the onset of the wet weather season to prevent damage to infrastructure and Coho salmon habitat. The work was completed right before a major rain event so the watershed group took the opportunity to evaluate the success of the treatments and to see if BMPs were properly implemented and effective. Two of the largest culvert upgrade sites were evaluated for sedimentation of channel riffle substrate, turbidity, disturbance to the channel, fill in channel, and fill on the floodplain. There was no discernible difference in riffle substrate above or below the culvert, nor was there a turbidity plume from construction activities. Fill from construction activities was not evident in the channel or on the floodplain. Though disturbance to the active channel was minimized, the slopes adjacent to the channel were disturbed and without soil cover. Correct action that was taken to reduce any risk of erosion by seeding and coving the bare slope with weed-free straw.

**Photo 18 a and b. In-channel construction evaluation before corrective action on the left and after corrective action on the right**

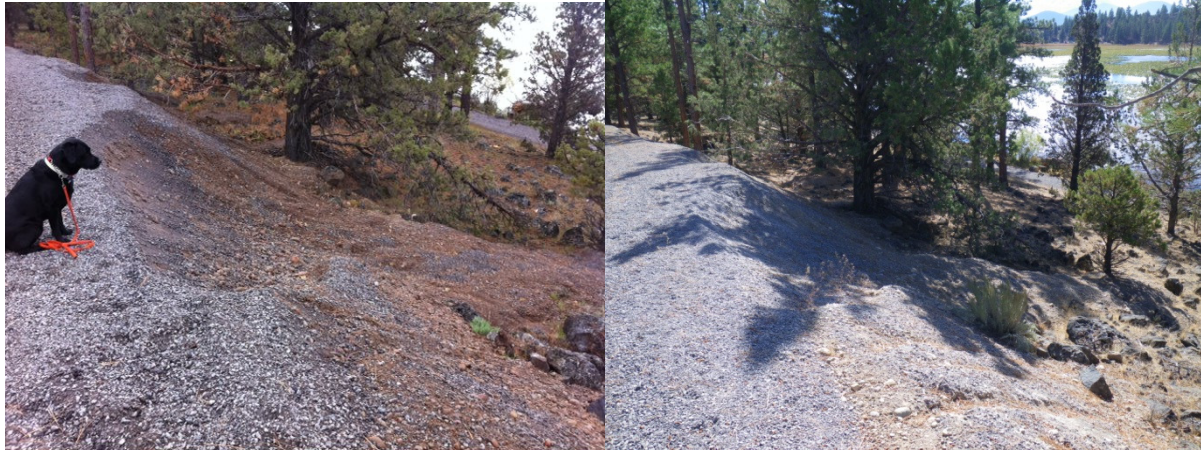
Orr Lake Rec. Dev. Project rd. 44N30X, Goosenest Ranger District- The fillslope of a road that was relocated away from Orr Lake was not hydro-seeded as specified in the contract and there were minor rills and slope failures. The erosion and slope failures on the fill slope were not at risk of delivering sediment into the lake. It appeared that the slopes had stabilized and needle cast had provided sufficient cover to prevent further erosion. Upon the follow-up site visit it was determined that no new slope failures or erosion had occurred on the fill slope.

**Photo 19 a and b. Fill slope stabilizing after failure. Photo on the left was taken in 2011 and the Photo on the right was taken in 2012.**

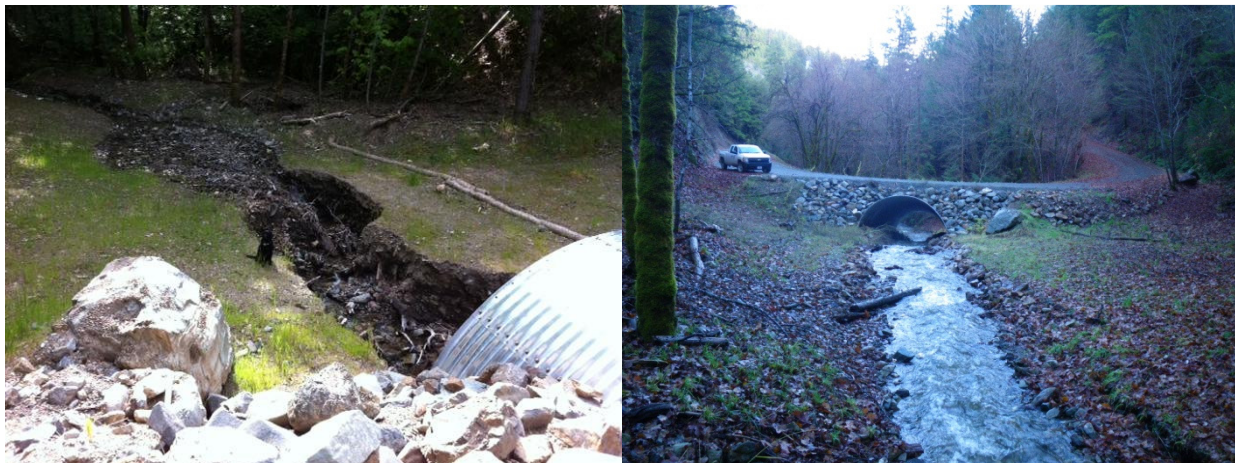
China-Fish Aquatic Passage ARRA rd. 47N77, Happy Camp District- The decision memo for Klamath Fish Passage Sites required that the fill material be excavated (approx. 550 ft<sup>3</sup>) to the depth of the original channel gradient and to the width of the canyon wall and/or floodplain at the base. Post-winter evaluation in 2011 showed that the debris deposit was not excavated to the original channel depth, instead the stream channel had incised with a 6 foot steep eroding bank. Engineers repaired the site in 2011 by excavating the debris deposit and extending the channel width back against the canyon wall. The follow-up evaluation in 2012 showed a stable stream channel that was excavated to the original depth and gradient, and armored with rock and gravel.

**Photo 20 a and b. On the left- Photo of incised stream channel upstream of the culvert replacement. On the right-Photo of a stabilized stream channel upstream of the culvert replace after fill material had been removed.**
